Hubble Space Telescope Servicing Mission Four (HST SM4) Unique Challenges for STS-125

The Hubble Space Telescope (HST) has nominally been serviced every three years; but seven years have now passed since the last servicing mission. The current mission (SM4) is much broader in scope than any before, demanding a much higher degree of safety participation in hardware design and mission operations. Unprecedented hardware installation includes batteries, a new science instrument computer and a Soft Capture Mechanism (a structure enabling the future safe de-orbit of HST). The mission includes challenging extra-vehicular activities (EVAs) to restore two instruments never designed for on-orbit repair. Following a successful five EVA day mission, a restored HST should return science well into the next decade and enable a safe de-orbit at the end of observatory life.

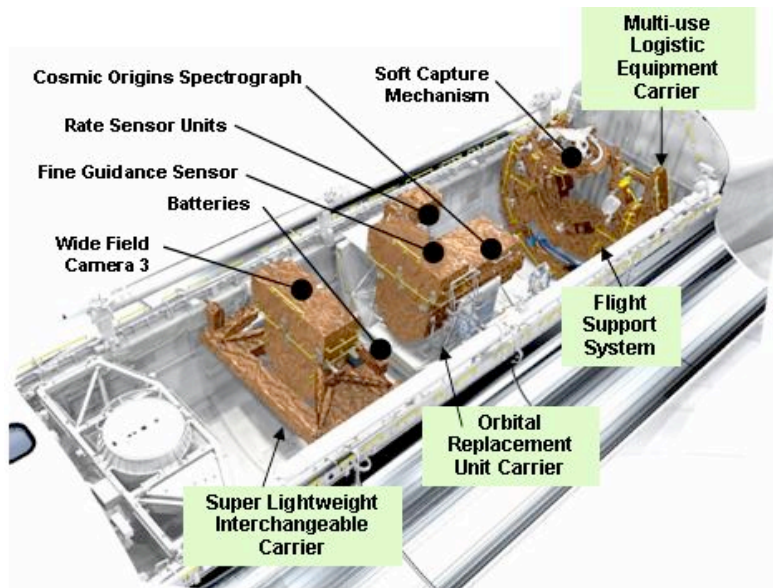
Figure 1 - SM4 Carrier and Orbital Replacement Unit Complement

The HST Flight Support System (FSS) was used on all previous servicing missions and will be used again for SM4. FSS provides mechanical and electrical interfaces between HST and the Orbiter for payload retrieval and on-orbit servicing. The FSS SM4 configuration provides the following services: HST berthing and positioning; HST latching and release (remotely operated); Orbiter and HST electrical power interfaces; HST optional reboost (structural configuration). Figure 1 shows the Space Support Equipment (SSE) or carriers and some of the hardware complement to be launched in support of SM4.

The Orbital Replacement Unit Carrier (ORUC), another reusable structure, provides stowage and environmental protection for the SIs and ORUs during an HST Servicing Mission. The ORUC structure supports a complement of SSE hardware and assorted crew aids and tools required for HST On-orbit Replacement Unit (ORU) servicing and change out functions. Its approximate launch weight is 7600 lbs. Stowage on the ORUC provides for carrying to orbit HST ORUs, and tools and for returning the replaced units and tools in suitable transport containers. The FSS supplies power and electrical interfaces for the ORUC via a mission unique harness from Shuttle inventory. Electrical circuits are limited to thermal control and monitoring, and status of SI latches in the science instrument protective enclosures

The Super Lightweight Interchangeable Carrier (SLIC) is new for SM4 and offers a lightweight alternative for the HST Servicing Mission 4 manifest. With its composite construction, this carrier departs from the traditional aluminum carrier structure both in terms of its weight and its expected performance. Like the ORUC, SLIC carries ORUs and tools and provides power and monitor capabilities using Orbiter power.

The Multi-Use Logistic Equipment Carrier (MULE) structure consists of hardware that was previously flown on several missions including: STS-109 as part of the HST SM3B mission ; STS-95 as part of the HOST mission that was launched on October 29, 1998; and STS-48 as part of the Upper Atmospheric Research Satellite (UARS) Observatory mission that was launched on September 12, 1991. The UARS hardware, which was re-flown for the HOST mission and HST SM3B mission, will now be implemented for the HST SM4 mission once again as the MULE. MULE carries ORUs (notably the SIC&DH replacement) and tools. MULE also provides a structural platform for the Relative Navigation System (RNS), an experimental platform for developing automated rendezvous techniques. As for the ORUC and SLIC, MULE provides power for heaters and monitors.

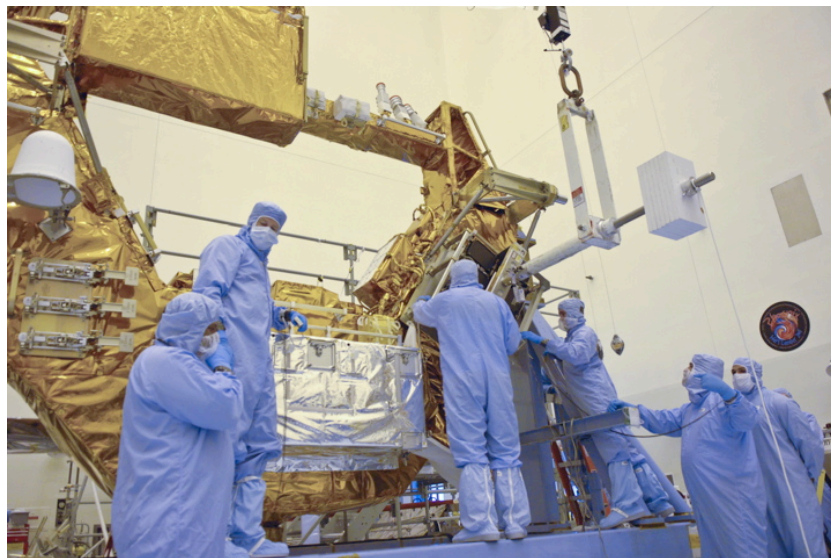
Figure 2 – SI C&DH Being Installed at KSC Prior to Flight

Having already provided for a full compliment of instruments and tools before the SIC&DH-R was added to the manifest, selecting an EVA accessible location which also provided heat and the ability to provide flexible interfaces was the next challenge. Fortunately, a location on the MULE carrier had been reserved in the event a spare reaction wheel was added. This was chosen for stowage of the SIC&DH. The SIC&DH Plate Assembly (SPA) was designed to provide the same interface for the SIC&DH as found on HST. The SPA design underwent several iterations to accommodate not only the expected thermal mismatch, but also the mechanism fault tolerance requirements enforced by Johnson Space Center's Mechanical Safety Working Group (MSWG). Additionally, the SIC&DH-R required modifications to its fasteners to compensate for the thermal distortion as the problem is expected to be worse on installation to HST. Figure 2 shows the SI C&DH being mounted for flight to the MULE.

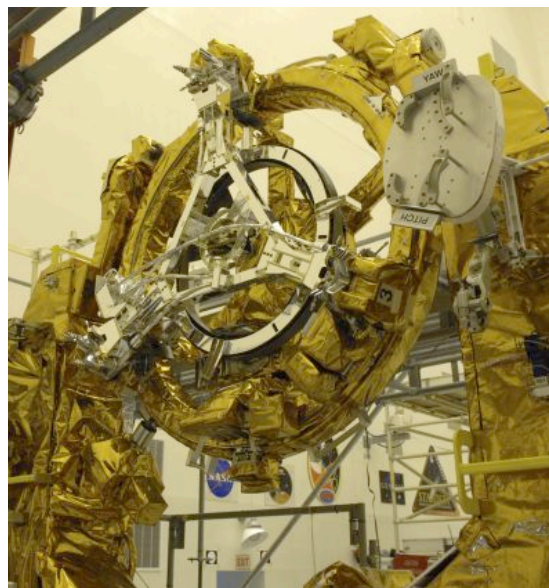
Figure 3 – SCM Shown on FSS

From the very beginning, HST's safety team followed the SCM design, performing an initiating event tree analysis (IETA) for each design iteration. HST's safety team became an integral member of the design team and influenced the design to insure that each major function includes safety features and EVA overrides. Additionally, steps were added into the EVA installation process to insure that the SCM is completely released from the FSS prior to connecting to HST. A contingency flow was constructed and provided to the EVA team to address potential cases identified as safety critical using the IETA. Figure 3 is a photo of the SCM as installed onto the FSS.

The following safety features were incorporated into the SCM design: Indicator lights and microswitches to insure that the crew can determine whether or not the remote drive functions properly; a mechanism to insure that the gearbox cannot inadvertently release or deploy the SCM attach or release mechanisms; overrides for attachment to FSS and HST; and overrides for release from HST and FSS

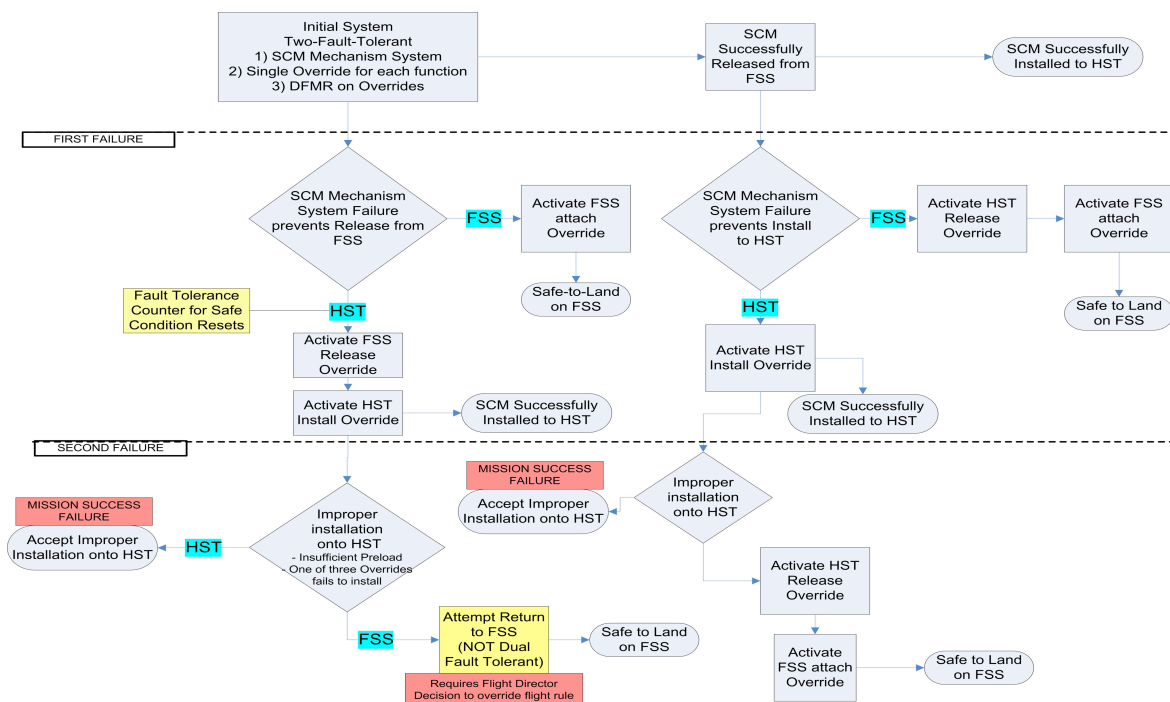
Figure 4 – Fault Tolerance Flow SM Safety and Mission Success

A major issue for SCM during the IETA was making the distinction between Mission Success and Safety. Since the SCM is to attach to HST, it must be designed so that, once installed, it does not interfere with HST's Pointing Control System (PCS). However, from a safety standpoint, SCM must simply either be detached from the FSS and sufficiently attached to HST so that, upon deployment, it flies with HST, or be safely attached to the FSS for landing. The IETA helped drive out these issues and led to clear distinctions between safety-related design issues requiring two-fault tolerance and mission success issues requiring single-fault tolerance. Figure 4 shows the final fault-tolerance flow diagram with the various paths for safety and mission success.

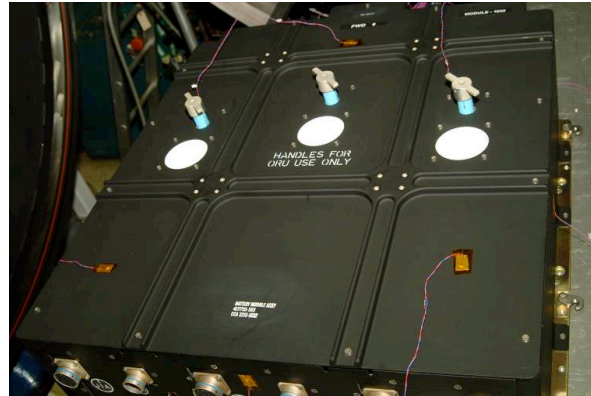
Figure 5 - HST SM4 Replacement Battery

The lack of back away prevention on the handle fastener of the switch was mitigated as it was discovered that loss of the handle causes the switch to close, energizing the connectors. Barrier analysis was applied to the switch to insure that, no matter what happened internally, the switch could not harm the crew. As a result, backaway prevention was added to the handle fastener and a non-conductive paint was applied to the switch handle. Figure 5 shows one replacement battery and the Battery Isolation Switch.

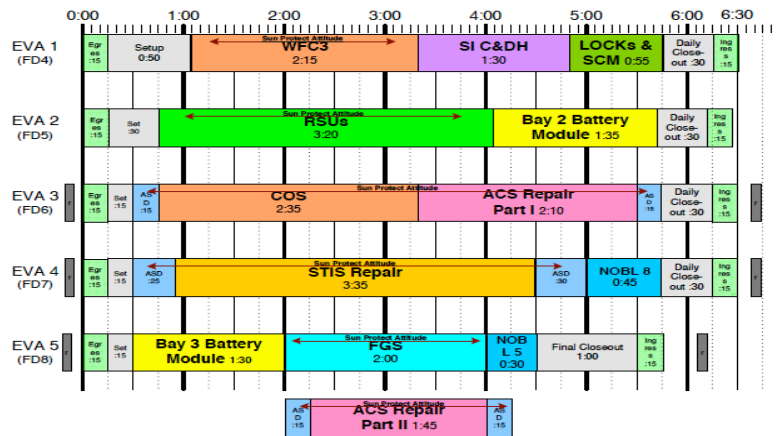
Figure 6 - HST SM4 EVA Timeline

The EVA timeline (Figure 6) identifies plans to replace and or repair HST systems. The timeline is carefully crafted for EVA efficiency so as to effectively use every second available for servicing. The first EVA will focus on replacement of Wide Field Camera (WFC) and Scientific Instrument Command and Data Handling module and addition of the Soft Capture Mechanism (SCM) and Latch Over-Center Kits (LOCKs). The second EVA will be used to enhance core HST systems with new rate sensor units (RSUs) and one battery module. EVA 3 tasks include the installation of the Cosmic Origins Spectrograph (COS) and begin repair of the Advanced Camera for Surveys (ACS). EVA 4 time will be used to repair the Space Telescope Imaging Spectrograph (STIS). EVA 5 will mark the final SM4 EVA with the replacement of the Fine Guidance System, completion of the ACS Repair activities, and replacement of the bay 3 battery module.
